CITY OF RICHMOND

REPORT TO COMMITTEE

RE: Knight Street Bridge Watermain

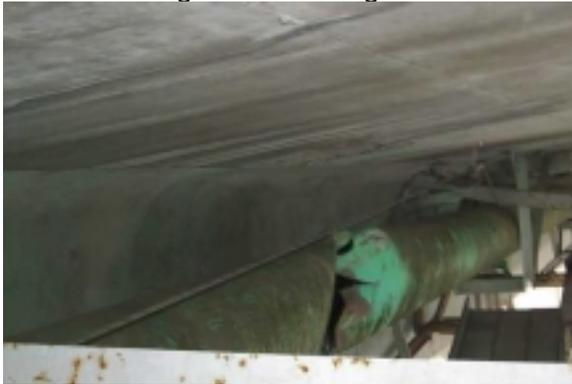
On January 15, 2000 a large construction crane under transport by a river barge collided with the deck of the Knight Street Bridge. This resulted in extensive damage to the access catwalk and the City of Richmond's 450 mm. watermain. This accident required shutting down this sole source water supply system for a total of 25 days. (see attached photo 1 / Attachment 1)

Photo 1 Damaged 450mm watermain under the Knight Street Bridge

The repair work to the bridge was contracted out to the engineering firm of Buckland and Taylor. Due to the damage location and height at which the repair crews were required to work, the lengthy repair and planning period resulted from the need to develop specialized work procedures, engineered designs and to secure equipment and materials for the watermain repairs.

The repairs by contractor to the watermain commenced on Feb 2, 2000 and were completed on Feb 4, 2000. City crews then started to, test and disinfect the watermain. The watermain was back into full service as of Feb. 9, 2000.

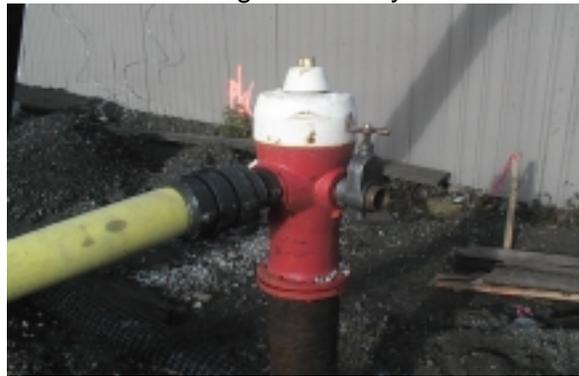
As this watermain is the only water supply to Mitchell Island, it was necessary to install a bypass water supply from the City of Vancouver. This was accomplished by utilizing the Vancouver Fire Department's emergency above ground water supply system, at a cost to the City of \$25,000. Vancouver's system may not be available for our use if another emergency event occurs where they also require the equipment. (see attached photo's 2 – 6 / Attachment 1)

Photo 2 Tie in to the Mitchell Island watermain through the fire hydrants

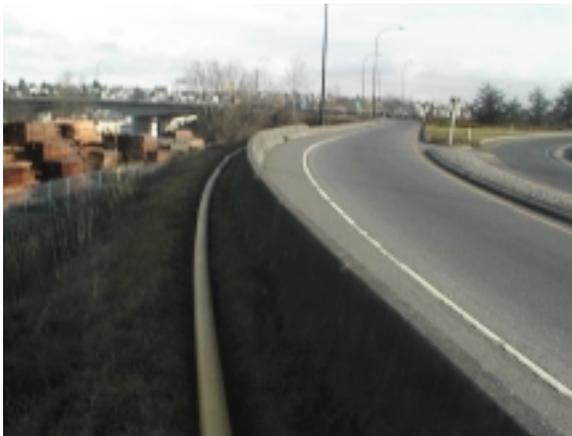
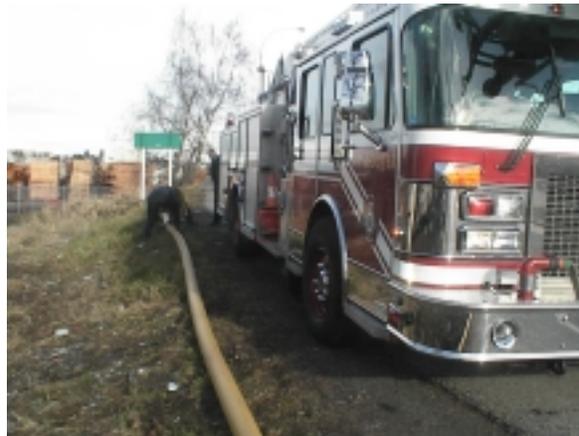
Emergency bypass hose beside the off ramp to Mitchell Island from Vancouver.
Photo 3 & 4

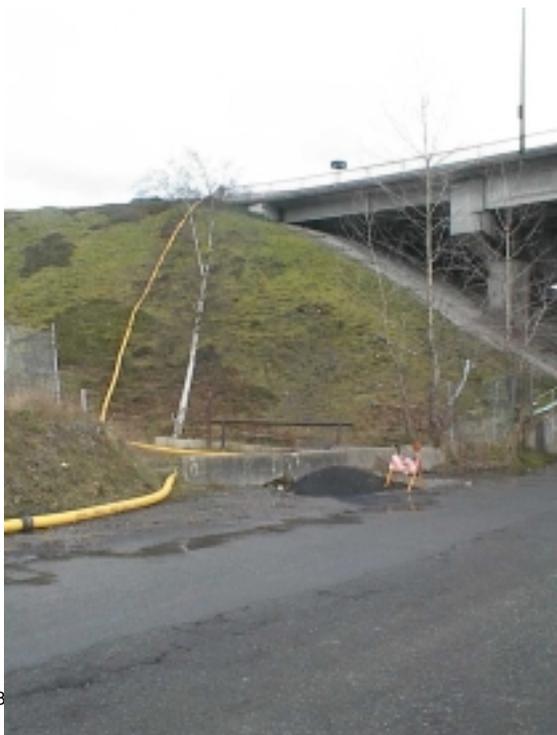
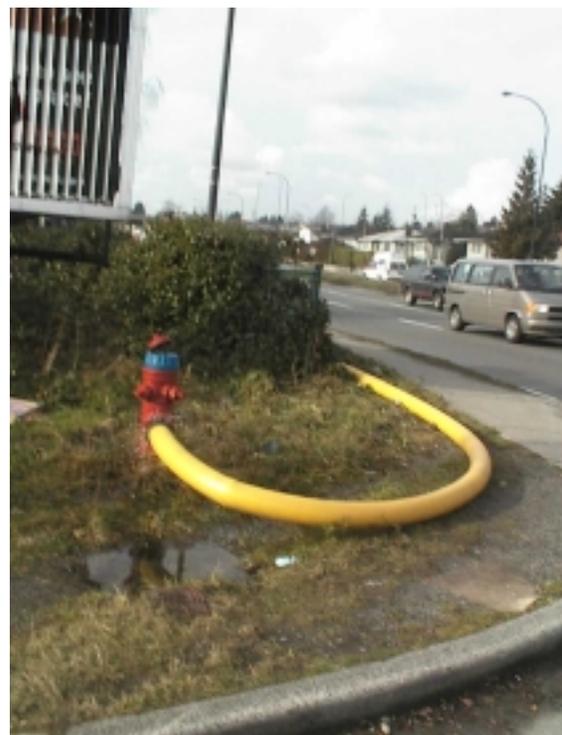
Photo 5 & 6 Vancouver side going to the bridge and source fire hydrant
