*To Council - Sept 10, 2007*  
*To Planning - Sep 6, 2007*  
Date: August 15, 2007  
RZ 07-375571  
*File: 12-8060-20-8292*

**To:** Planning Committee  
**From:** Wayne Craig  
Acting Director of Development  
**Re:** Application by Hari and Gurinder Gill for Rezoning at 7520/7540 Langton Road from Single-Family Housing District, Subdivision Area E (R1/E) to Single-Family Housing District, Subdivision Area B (R1/B)

**Re: 7520 & 7540 Langton Road, Richmond - ARBORIST'S REPORT**

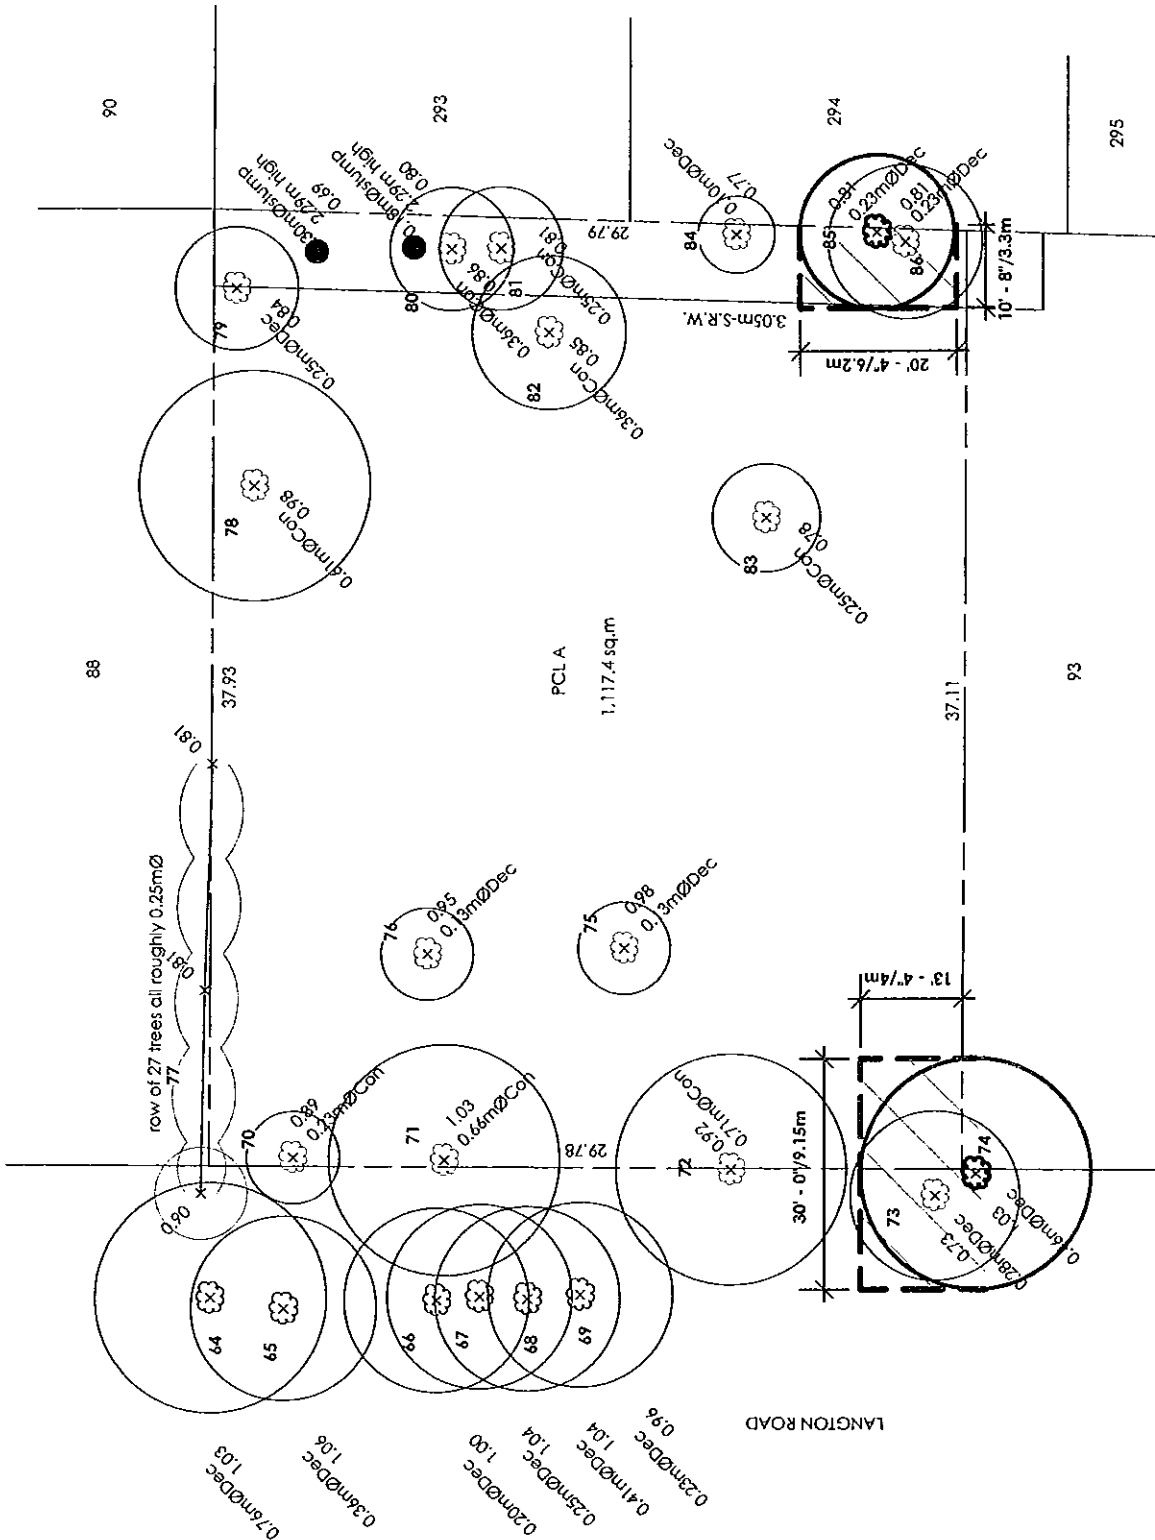
**ARBORIST REPORT**

TREE NUMBERS REFER TO TAGS ON TREES.  
 TREE PROTECTION AREA: DIMENSION TREE PROTECTION BARRIERS AS SHOWN (TO DRIPLINE) BARRIERS TO BE AT LEAST 1.2M HIGH AND UNSTRUCTURED OF ORANGE SNOW FENCING SECURELY FASTENED TO WOOD OR METAL STAKES, OR PLYWOOD FASTENED TO WOODEN STAKES, OR OTHER BARRIER SATISFACTORY TO MUNICIPAL STAFF. INSTALL SIGNAGE AS PER CITY OF RICHMOND REQUIREMENTS.

NO MATERIALS STORAGE OF ANY KIND, VEHICLE TRAFFIC OR PARKING WITHIN PROTECTION AREA.

TREE TAG #74 (.46m dia.) – Birch Tree privately owned by neighbor to the south (lot 93) and partially in the City of Richmond street allowance. More open grown than the other Birches, this tree has a more representative form of the species, and is in slightly better vigor and health as a result. It has some organic debris piled near the base. Overall I rate it in FAIR condition and have provided dimensioned tree protection barriers on the Plan.

TREE TAGS #85 & 86 (both .23m dia.) – Birch Trees in the rear yard in the S.R.W. Codominant trees of the same age, these two trees have good form and reasonable vigor. Overall I rate them in GOOD condition and have provided dimensioned tree protection barriers on the Plan.
