# City of Richmond

**To:** Public Works and Transportation Committee  
**From:** Milton Chan, P.Eng  
 Director, Engineering  
**Re:** South Dike Repairs – Gilbert Road Area

**Date:** January 19, 2021  
**File:** 10-6050-01/2021-Vol  
 01

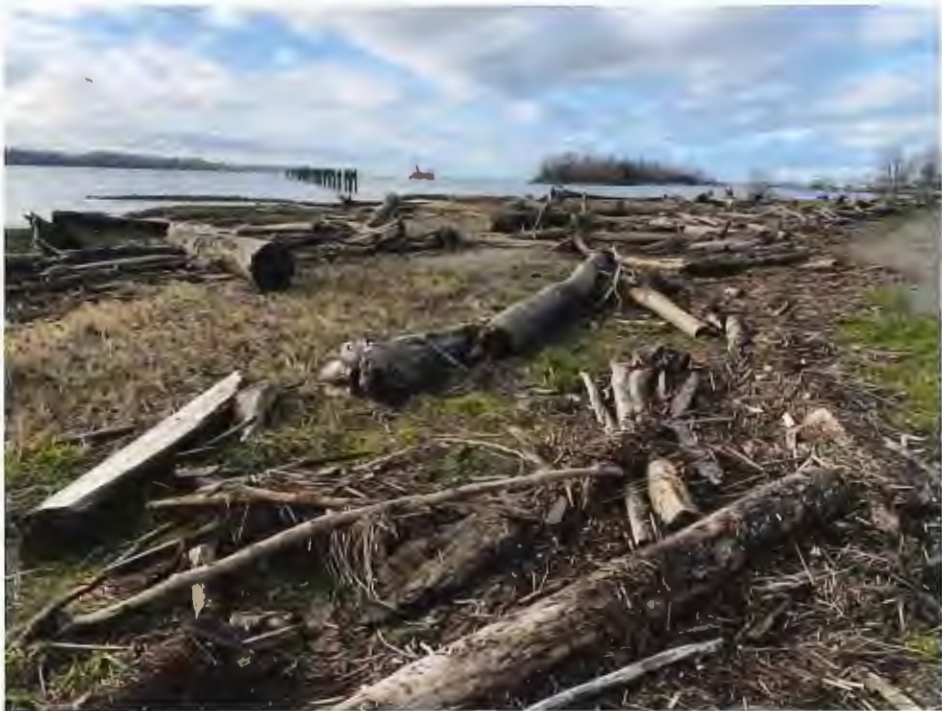
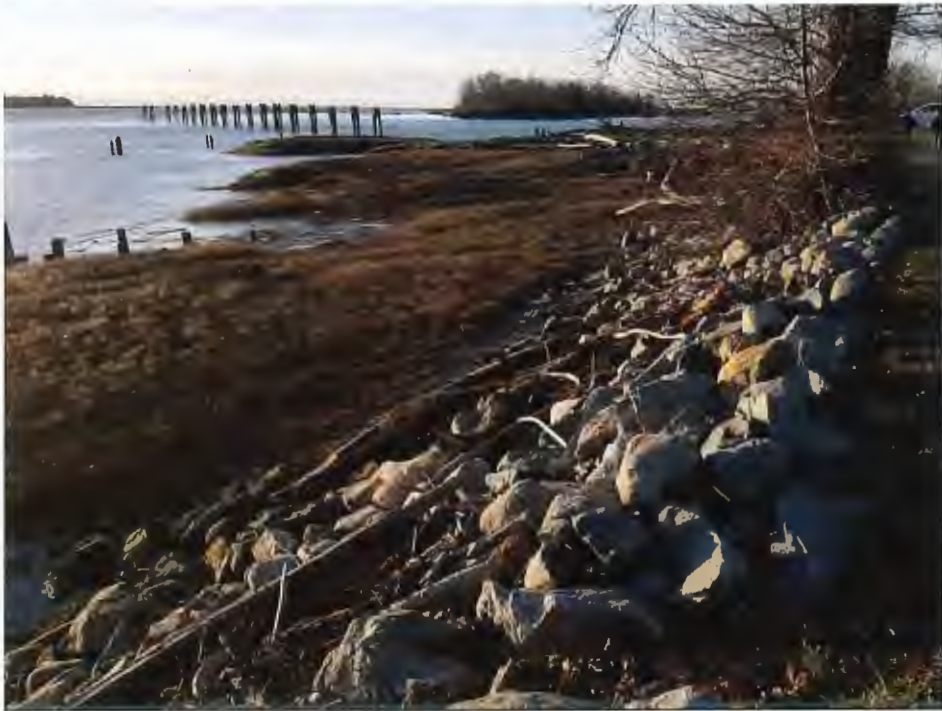
Debris Build-up and Dike Armour Damage

As a result of the recent winter king tide and storm events, a build-up of debris, mostly consisting of large logs and branches, accumulated along the Gilbert Road south dike area. In combination with the storm and king tide events, the woody debris dislodged portions of the rip-rap armour.

The scope of work includes inspection, reinstatement of rip-rap armouring along a 300 m stretch, debris removal along a 750 m stretch, and any necessary permitting to complete the work.
